# Construction Progress Report

Wind farm earthworks, Scotland

SURVEY DATE

**08/05/2026**

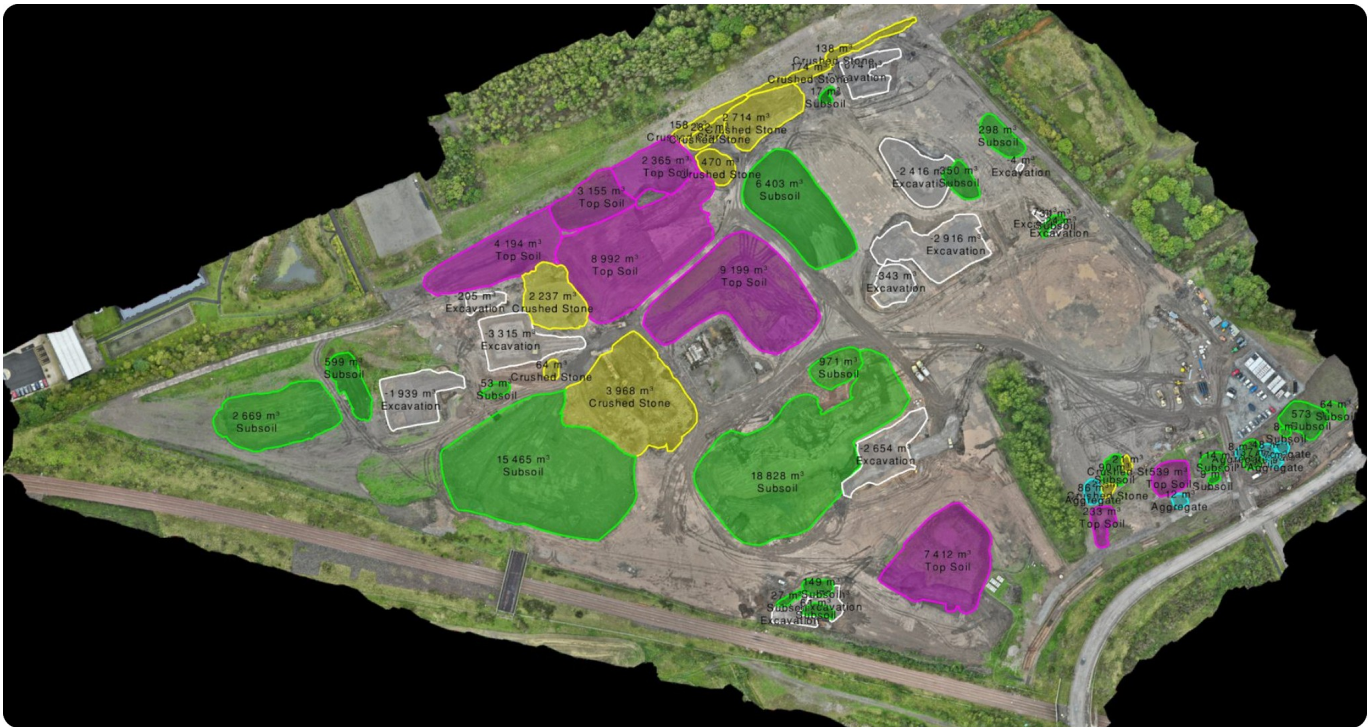
# Every stockpile and excavation, measured

Each area outlined, labelled by material and measured from the survey surface. Not estimated.
